# Dental Preparation with Sonic vs High-speed Finishing: Analysis of Microleakage in Bonded Veneer Restorations

**Purpose:** To compare marginal microleakage in porcelain veneer restorations following dental finishing using two types of instruments to test the hypothesis that microleakage will be less when teeth are prepared with sonic oscillating burs than when prepared with high-speed rotating burs.

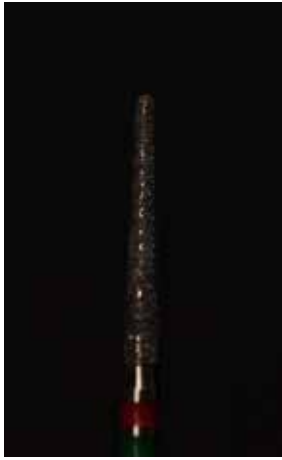
**Fig 1** High-speed diamond bur used for finishing.

Twenty-eight teeth were prepared using a KAVO Super Torque 660 turbine with a high-speed rotary diamond bur (Komet, 151- $\mu$ m body/45- $\mu$ m tip; lot 521443). The preparation areas were then polished using a finer-grained (45  $\mu$ m) bur (Komet, Lot 235079) (Fig 1).

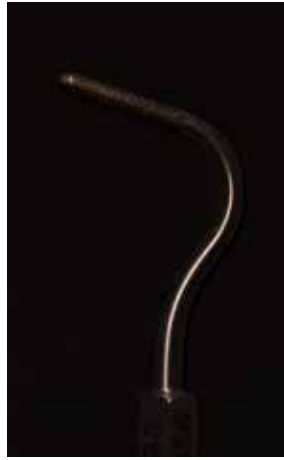
**Fig 2** Oscillating diamond bur used for finishing.

The remaining 28 specimen teeth were prepared using the same turbine and bur type as above, but finishing was performed using a Kavo Soniflex 2003L oscillator fitted with a diamond bur (Komet, 45  $\mu$ m) (Fig 2).

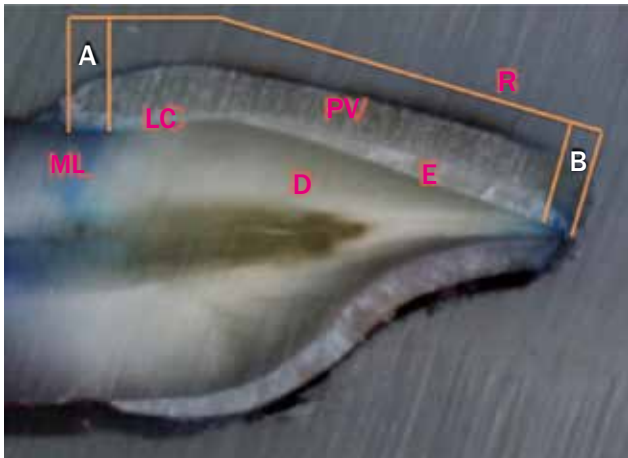
**Fig 3** Lengthwise section of veneered tooth. PV: porcelain veneer; LC: luting cement; E: enamel; D: dentin; ML: microleakage (blue area); R: total length of veneered tooth. A: % microleakage in cervical area; B: % microleakage in incisal area.

Microleakage was evaluated using an optical microscope (OPMI Pico dental microscope, Zeiss; Jena, Germany) and a millimeter ruler (Leone T3612-00; Firenze, Italy) to measuring the length of microleakage shown as a blue stain from the 2% methylene blue solution. Leakage was classified as follows:<sup>13</sup> cervical: reaching from the cervical edge towards the center of the veneer, expressed as a percentage of the total cervical-incisal veneer length; incisal: reaching from the incisal edge of the veneer towards its center, expressed as a percentage of the total cervical-incisal veneer length (Fig 3).

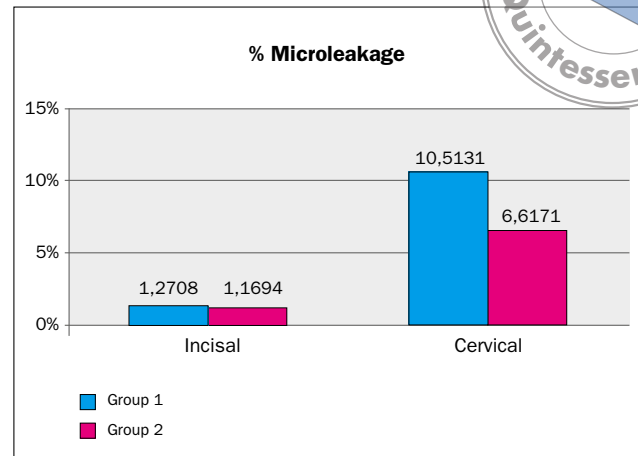
**Fig 4** Bar graph comparing incisal and cervical microleakage for the two groups. Cervical microleakage was 10.5% in group 1 and 6.6% in group 2. Incisal microleakage was 1.3% in group 1 and 1.2% in group 2. Values above bars are percent microleakage.

Cervical microleakage was 10.5% in group 1 and 6.6% in group 2, which was statistically significant. The difference in incisal microleakage between groups was lower and not significant: 1.3% leakage in group 1 vs 1.2% in group 2 (Fig 4).
